**EXAMINING POOR DRAINAGE IN BWAISE II PARISH, KAWEMPE DIVISION,
KAMPALA**

**A DISSERTATION SUBMITTED TO THE POSTGRADUATE SCHOOL AS PARTIAL
FULFILLMENT FOR THE REQUIREMENTS FOR AWARD OF MASTERS DEGREE
IN NATURAL RESOURCES MANAGEMENT OF NKUMBA UNIVERSITY**

SEPTEMBER 2011

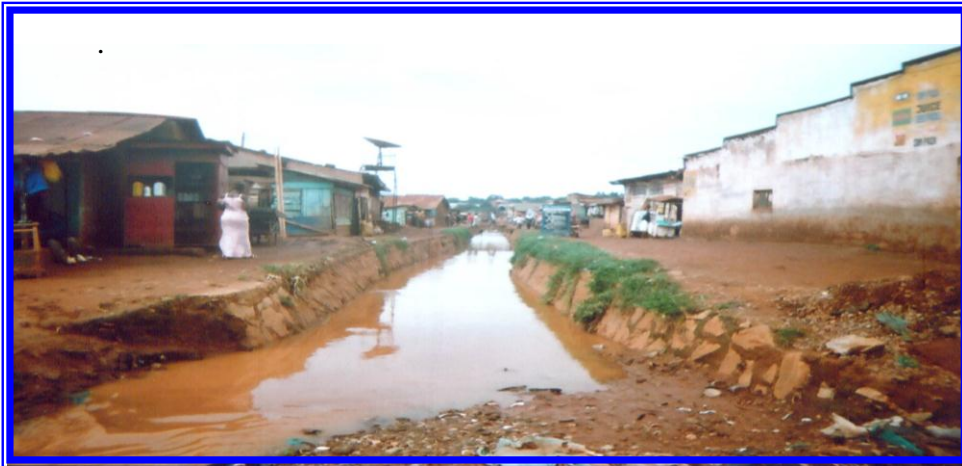
Plate 1: Blockage by silt, garbage and sediments in the Nakamiiro Channel in Bwaise II Parish.

The local community uses the wastes generated and dumps them in the wetlands supposedly to fill them up for settlement. Consequently people have almost built the entire swamp area which used to act as sponge to absorb the excess water which Nakamiiro Channel could not carry immediately. In the process they also covered the already existing narrow drains; and when it rains flooding is inevitable. It was discovered that the blocking of the drains with solid wastes dumped directly in the swamp is the major factor causing flooding and water logging in the areas (Plate 1).

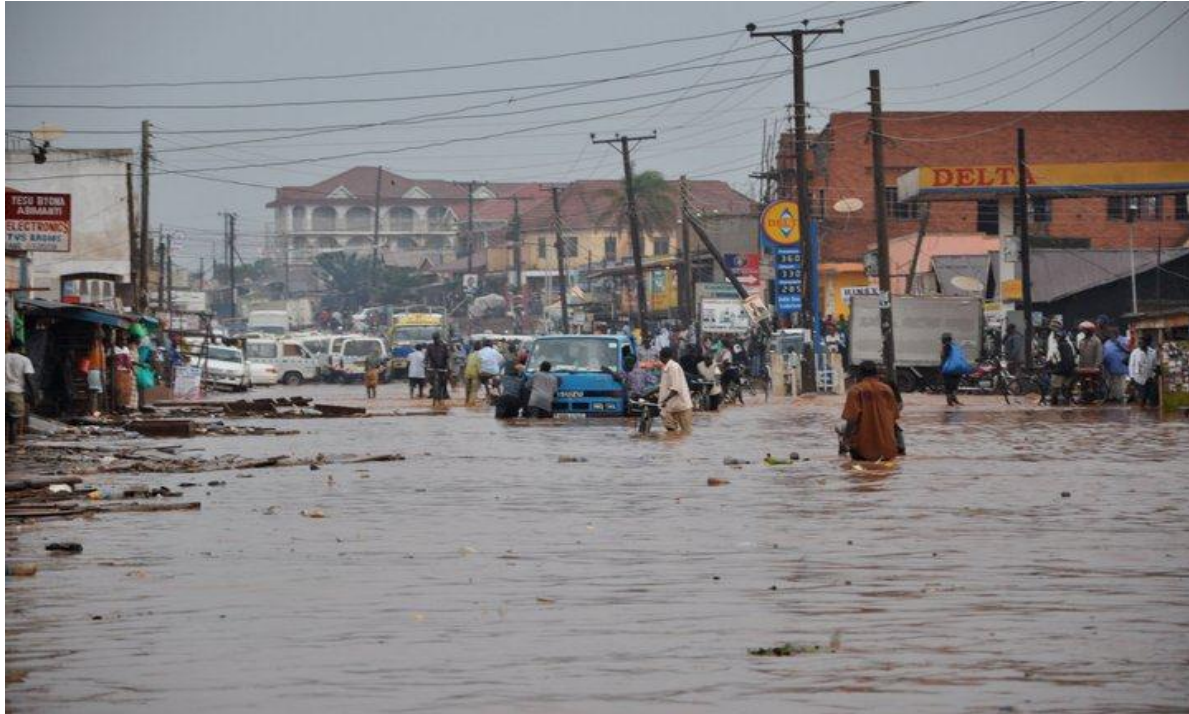
Plate 2: Effects of poor drainage on transport in Bwaise II Parish whenever it floods. Taken from the monitor newspaper archives

Poor drainage in itself can bring about flooding which in most cases submerges the buildings, roads and makes it hard for people to move about. Usually those with no alternative means remove their shoes and cross while others pay someone to sail them aboard on a bicycle or on their backs (Plate 2)

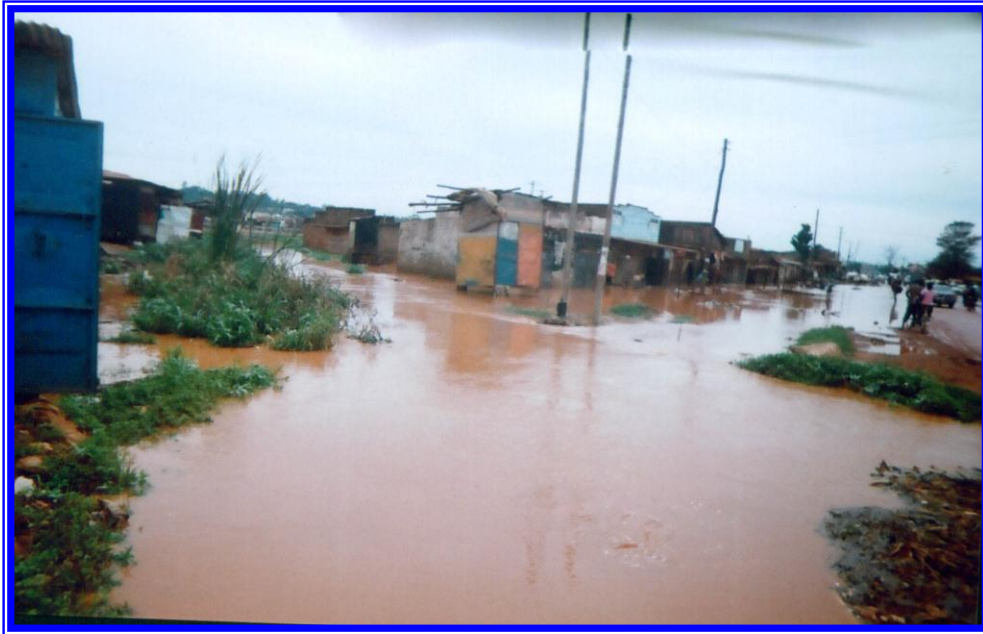
**Plate 3: Effects of flood water on houses in Bwaise II Parish after heavy rains.
Taken by the researcher in the field**

Whenever it floods in Bwaise II Parish 70.2% of the respondents reported that the people take longer routes to travel because the accessible routes get blocked off by the flood water which increases the amount of time spent to get to work (Table 13). While 20.0% don't travel at all thus denying them of work and income for livelihoods. The responses for the remaining 09.8% hire bicycle men to ferry them across at great risk of falling down who are at a risk of falling in the moving water sometimes with lethal results. Floods are also responsible for the loss of land through inundation. The original size of land one owned before flooding is seriously reduced (Plate(3)).

New Vision (1999) reported a story in line with (Plate 3) where ‘several houses were lost in a heavy down pour and subsequent floods which hit Kampala and its suburbs on Wednesday October 13th 1999. The worst hit areas were Kalerwe and Bwaise, where homes became inaccessible and five people were rescued from drowning. The floods up to window level submerged roads and entered people’s houses living household properties wet and damaged. Offices, machines and commercial property worth millions of shillings were also lost in those floods.

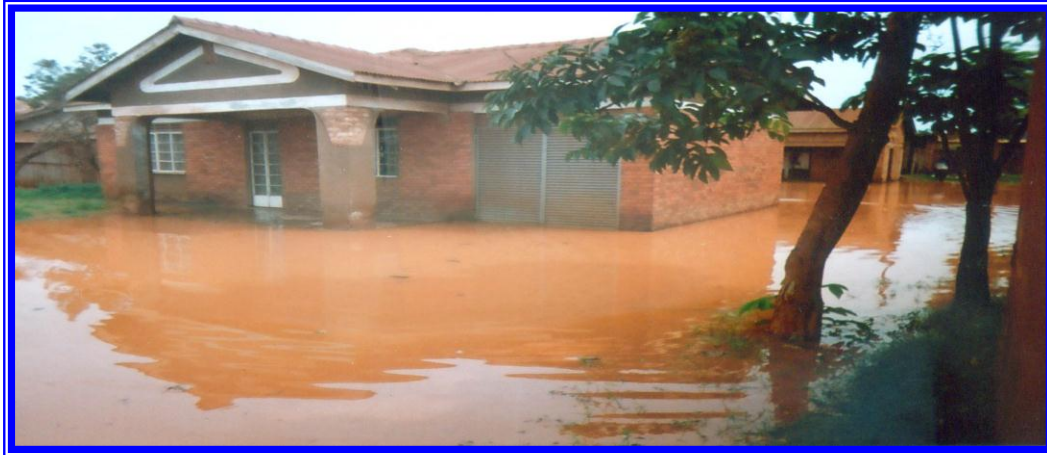
Plate 4: Effects of poor drainage on the quality of living in Bwaise II Parish whenever it floods.

Economically most people whose employment levels do not go beyond the jurisdicted flooded area are affected. Those engaged in business in the Katale zone, brick makers and many other activities have their work affected for months till the water sub-sides leaving their business capital destroyed. Raj (1991) identified water logging as one of the causes of poor drainage. The causes of water logging are both natural and artificial. The quality of housing is also affected by the floods. The submerged water soaks the walls resulting into cracking of the walls and

weakening the structure (Plate 4). This puts the house dwellers in an accidental situation for their lives.
